Building Damage and Business Continuity Management in the Event of Natural Hazards: Case Study of the 2004 Tsunami in Sri Lanka

Sustainability **2013**, *5*, 456–477; doi:10.3390/su5020456

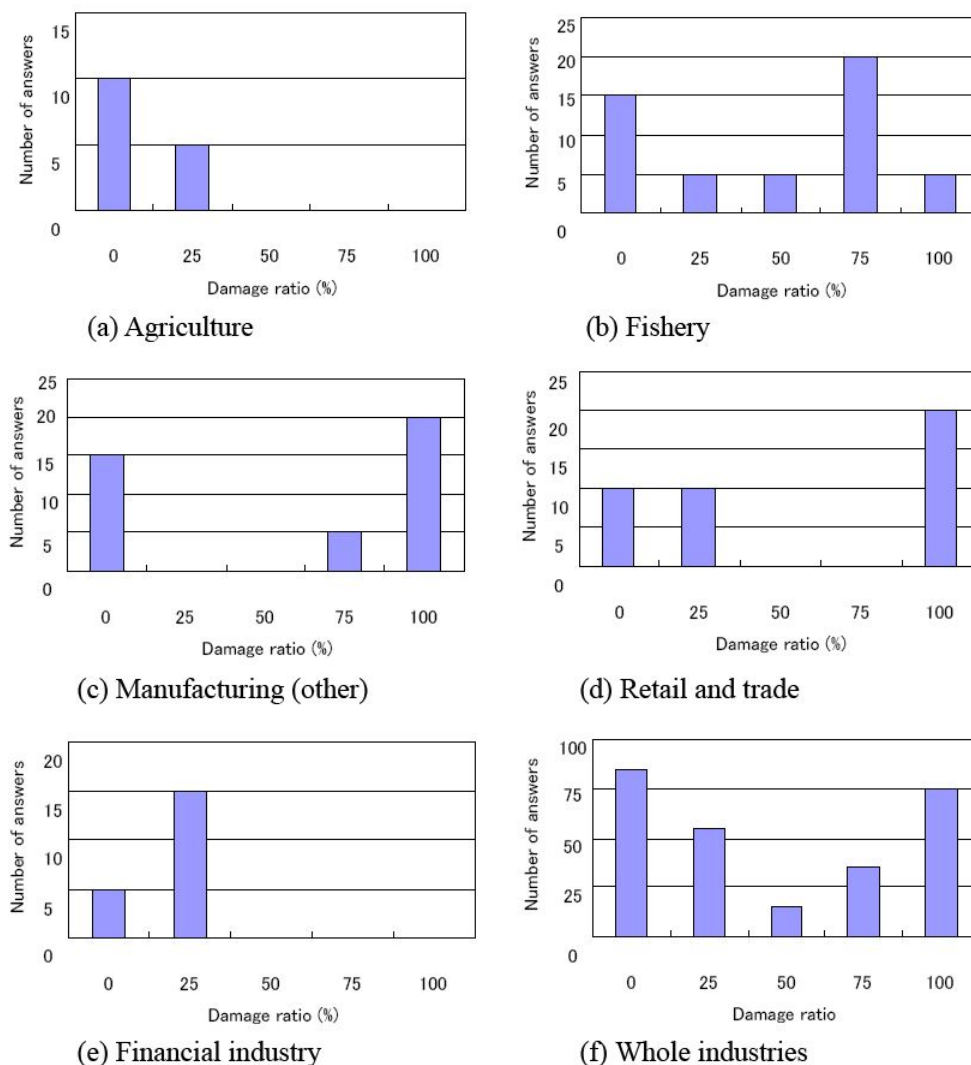
Figure 3. Damage to building facilities.

Figure 3 shows the total building damage percentage of each industry. Most of the buildings in this local area were made of bricks or reinforced concrete. However, in case of buildings located near the coastal area, not only infill walls but also concrete frames were washed away by the tsunami severely.

As regards the fact that most of the concrete frames were damaged and or washed away, it is difficult to recognize the places of reinforcing rods. In addition, most of the buildings in manufacturing industries and retail trade had 100% damage. On the other hand, the finance business and lifeline companies had little damage.

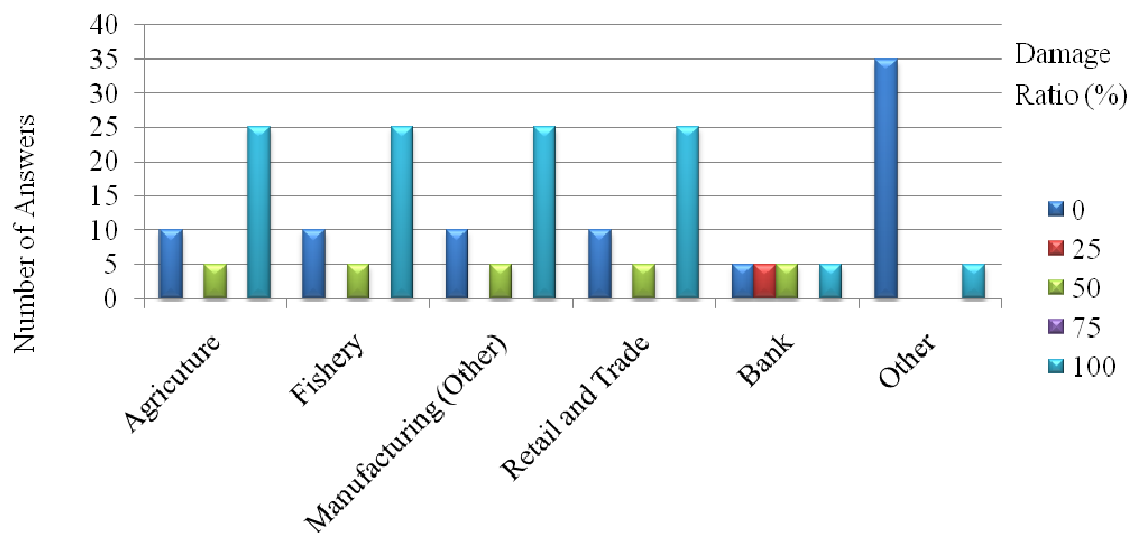
Figure 4. Damage to industrial facilities.

The damage to the industrial facilities is shown in Figure 4. The types of facilities are different in each company, except financial (banks) and lifeline companies, in which the percentage of damage concentrates from 0% to 100% and becomes a concave distribution. From the individual answers of the investigation, the facilities inside the buildings were buoyed with the flood current, including debris. In many places, electric facilities soaked in seawater did not report massive damage to the outside of facilities, but their internal electricity systems tended to break down. The facilities of an ice making company were heavily damaged including equipment such as electric generators and other ice plant devices.

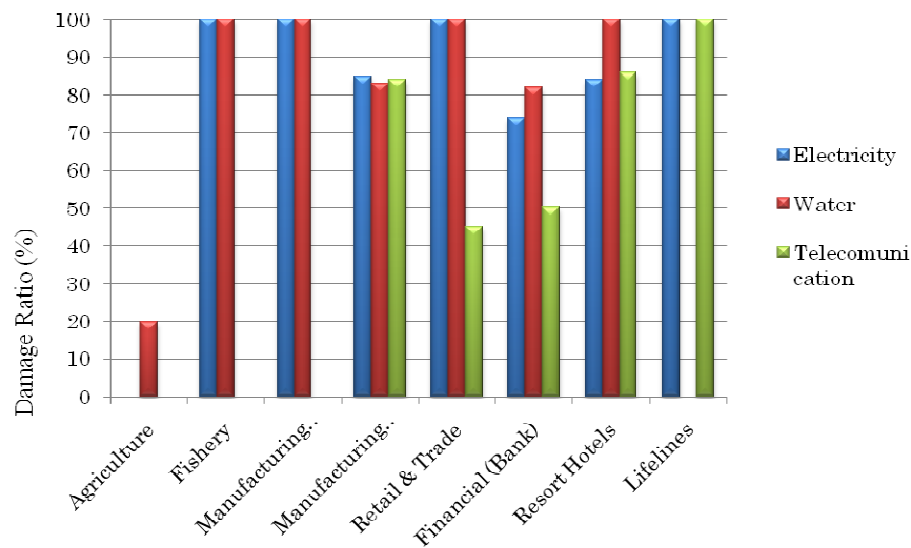
Figure 5. Damage condition of lifeline.

Moreover, the three lifelines of electricity, water supply and telecommunication have been investigated. Because the study area had not a gas pipeline but LP (Liquid Petroleum) gas cylinders, the gas lifeline was removed from this analysis. In terms of water supply, most of the families in the countryside usually use well water. However, in this study, we were concerned with the damage related to piped water. Figure 5 shows the supply situation of lifelines according to each type of industry. In case of agriculture, they were located far from the coastline, thus protecting them from the tsunami damage in Galle. Comparing three lifeline systems, on average 84% of the electricity system and 75% of the water supply system were out of service after the tsunami. However, the telecommunication system had less damage compared with other lifelines. The people already use mobile telephones, and therefore the influence of blackout was small for fixed lines.
